PRE - PURCHASE VISUAL PEST INSPECTION REPORT

PROPERTY ADDRESS:
14 George Mobbs Drive, SAMPLE

DATE OF INSPECTION:
30th Day of August 2016

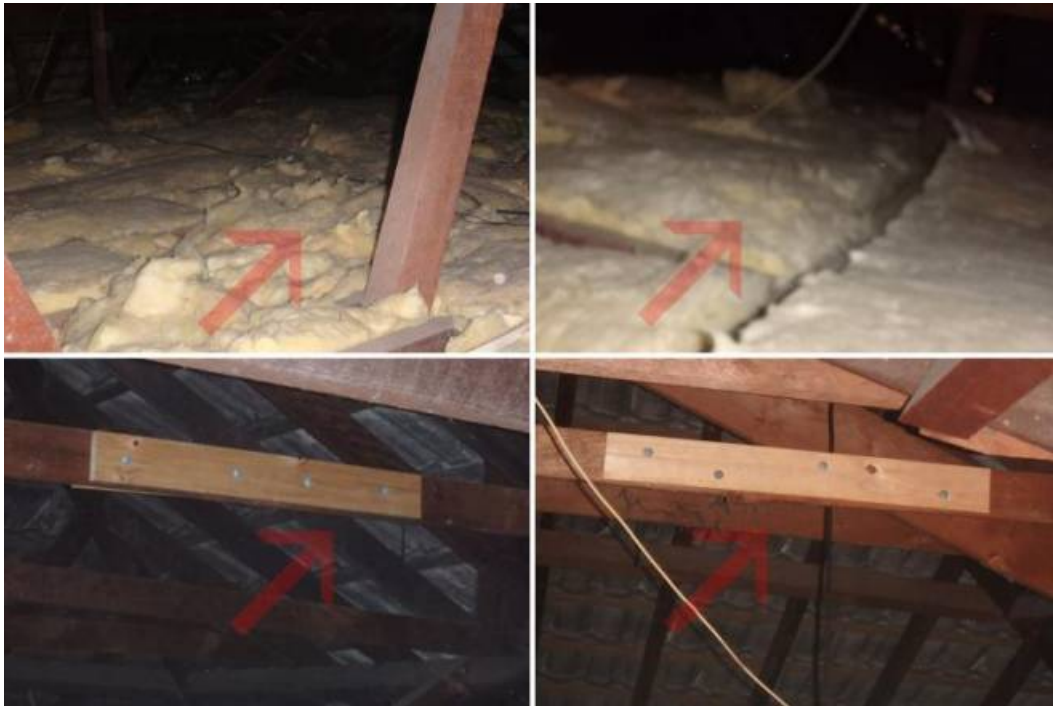
Insulation is present in the roof cavity. This restricted inspection to some roofing timbers. Removal of insulation is not within the scope of a standard visual timber pest inspection report however, this would be necessary for a more complete report to be submitted.

The entire roof void: Various areas of the roof void:

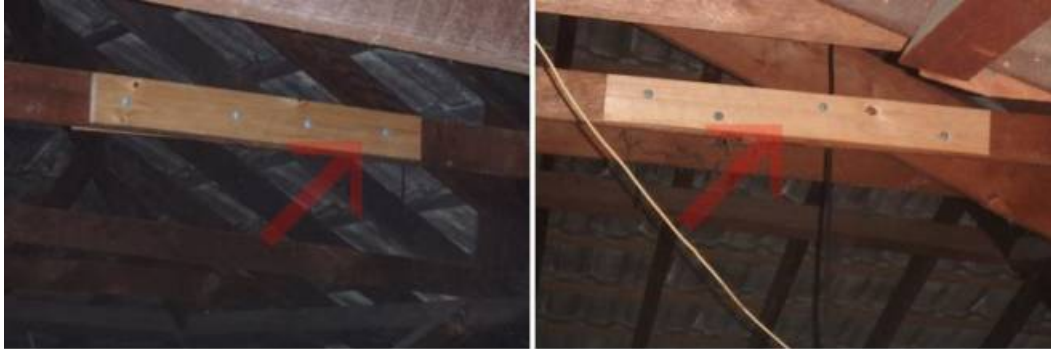
Some timbers (listed below) appear to be new or not the original timbers. This replacement may have been due to timber pest attack or some other factor. We recommend if you are using this report to purchase this property, further enquiries should be made to determine the reason for timber replacement.

Left hand side: Right hand side:

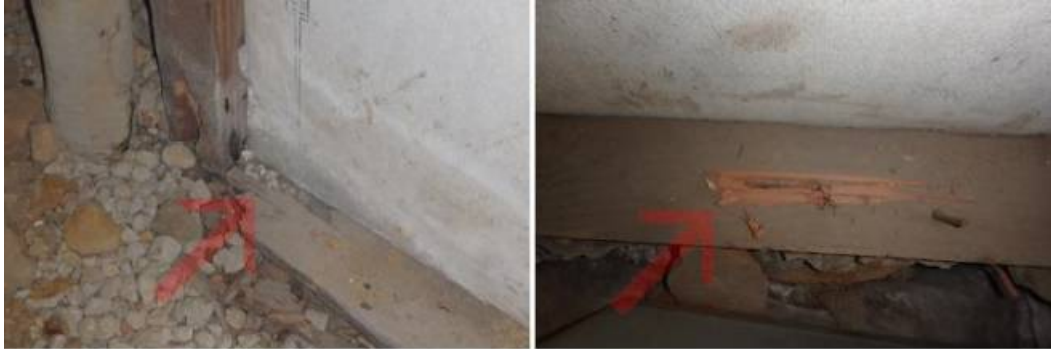
Yes - Inspection revealed currently inactive termite attack (damaged timbers and/or termite workings) within this area including but not necessarily limited to the following timbers and the areas listed below.

Bottom wall plate/s:

Front section of the structure:

Visible timber damage appears moderate however, we are not builders and this is not to be considered a builder's opinion. Refer to the definitions section of this report - Section 1.6 - Timber Damage.

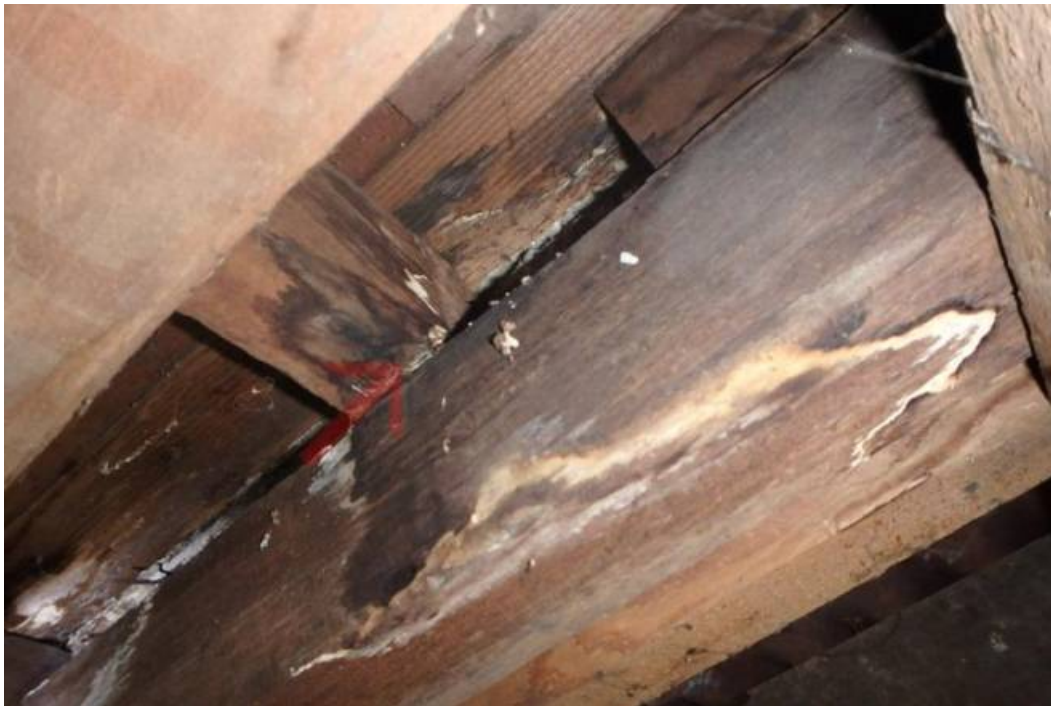
Main bathroom:

Yes - Wood decay damage was noted to the following timbers/areas.

Visible timber damage appears minor however, we are not builders and this is not to be considered a builder's opinion. Refer to the definitions section of this report - Section 1.6 - Timber Damage.

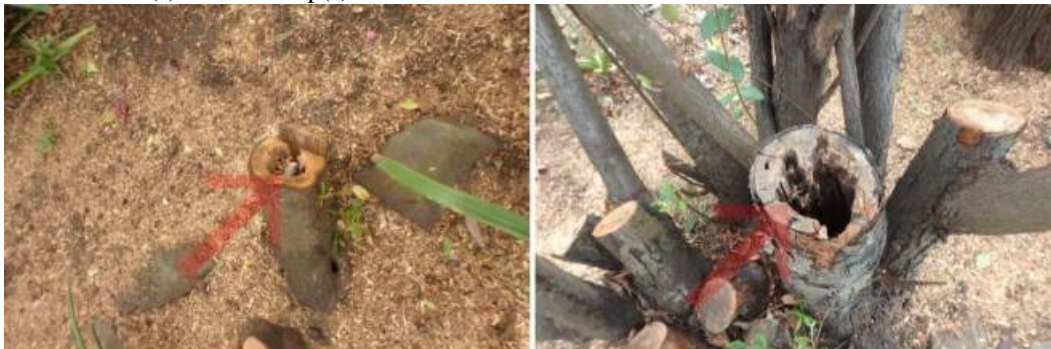
Yes - Inspection revealed currently inactive termite attack (damaged timbers and/or termite workings) within this area including but not necessarily limited to the following timbers and the areas listed below.

Tree(s): Tree stump(s):

Front section of the property:

Visible timber damage appears moderate however, we are not builders and this is not to be considered a builder's opinion. Refer to the definitions section of this report - Section 1.6 - Timber Damage.

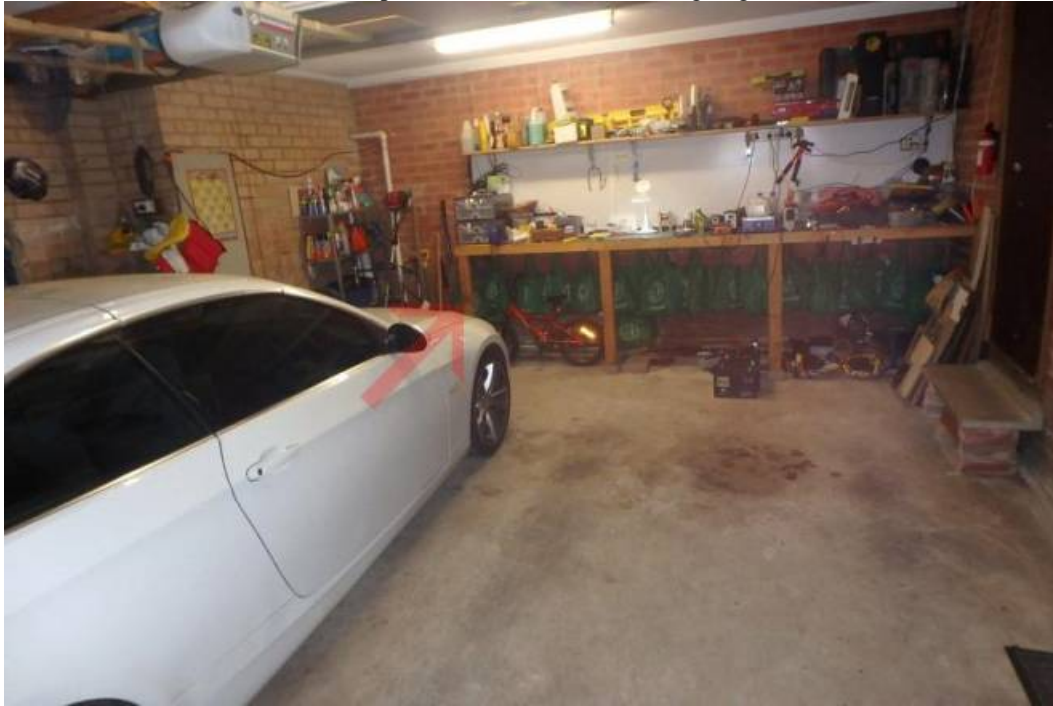
Stored items restricted inspection to the interior of the garage.

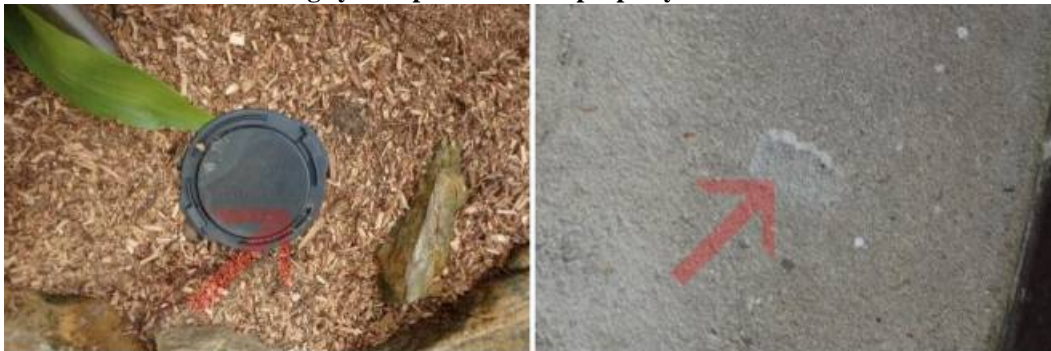
We found evidence that a termite treatment may have been carried out to this property. Where any evidence of a termite treatment or termite management system was noted, we strongly recommend any prospective purchaser research the documentation available in relation to this property and seek further information from the vendor in relation to any previous termite attack. The following evidence was found during our inspection. Evidence of drill holes were noted to concrete areas. Drill holes are an indicator that the area or areas may have been treated by chemical injection in respect to termite control or protection. Timber pest damage may exist in concealed areas. You should have an invasive inspection carried out and have a builder determine the full extent of any damage. We found evidence of a termite baiting system present at the property.
