Pre-Purchase Building Inspection Report

(In accordance with AS4349.1 2007 'Inspection of Buildings')

1/251 Sample Rd, COOGEE

Report Number: 1-1 Sample Building Report

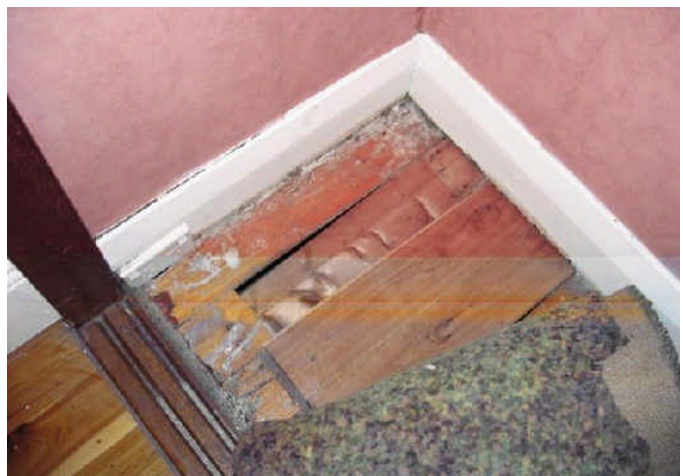
Main bedroom: wardrobe.

Timber strip floor boards loose and will require repair.

A licensed carpenter should be called to make a further evaluation and repairs or rectification as needed.

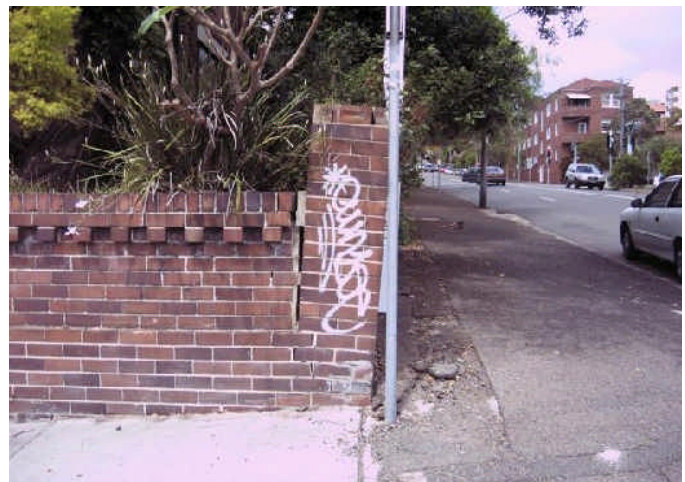
The masonry retaining walls show normal deterioration, cracks etc, and should be monitored for any movement.

Cracks are evident. Visible cracking has been categorized as an appearance defect. Cracking of a building element is an appearance defect where in the opinion of the inspector the appearance of the element is blemished however, the expected consequence of this cracking is unknown until further information is obtained.

Cracking can be expected in a building of this age and construction.

A licensed builder should be called to make a further evaluation and repairs or rectification as needed.
